CR 84.022

FIELD STUDY ON MOISTURE PROBLEMS IN EXTERIOR WALLS OF  
FAMILY HOUSING UNITS AT NAVAL AIR STATION PENSACOLA, FLORIDA

February 1984

An Investigation Conducted by  
H.R. TRECHSEL ASSOCIATES  
P.O. Box 211  
Germantown, MD 20874

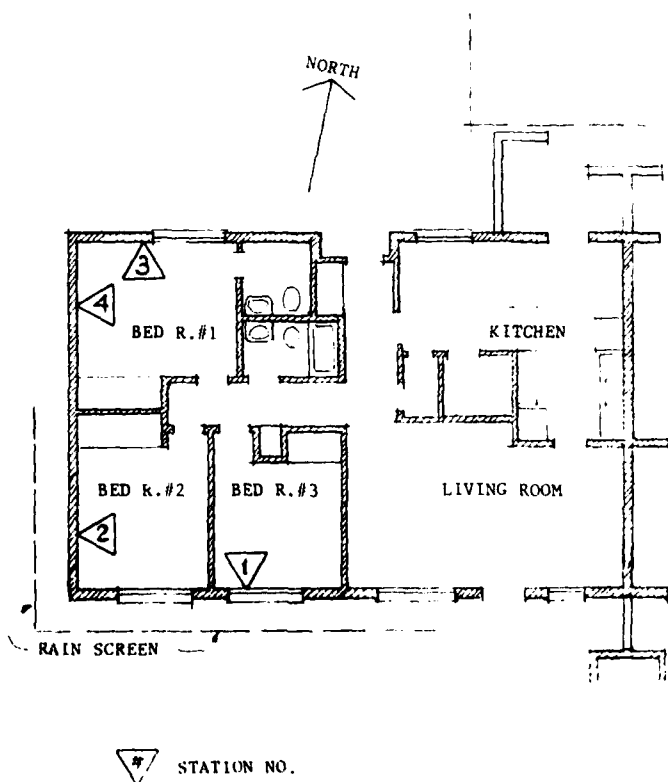
The probe locations (Stations) are shown on Figures 7 and 8. Probes 1, 2, and 3 were the original locations (2 and 3 having both a high top and a low bottom location). Probes 4 (also top and bottom) and 3 A, B, and C were added later. Because both temperature and RH were virtually identical for the top and bottom Stations, the bottom Stations for 2, 3, and 4 were discontinued after an initial number of readings. Stations 1 and 2 were behind the rainshield. The wall outside probes 3 and 4 was exposed to the weather.

Figure 7. Stations In Corry Field House - Floor Plan

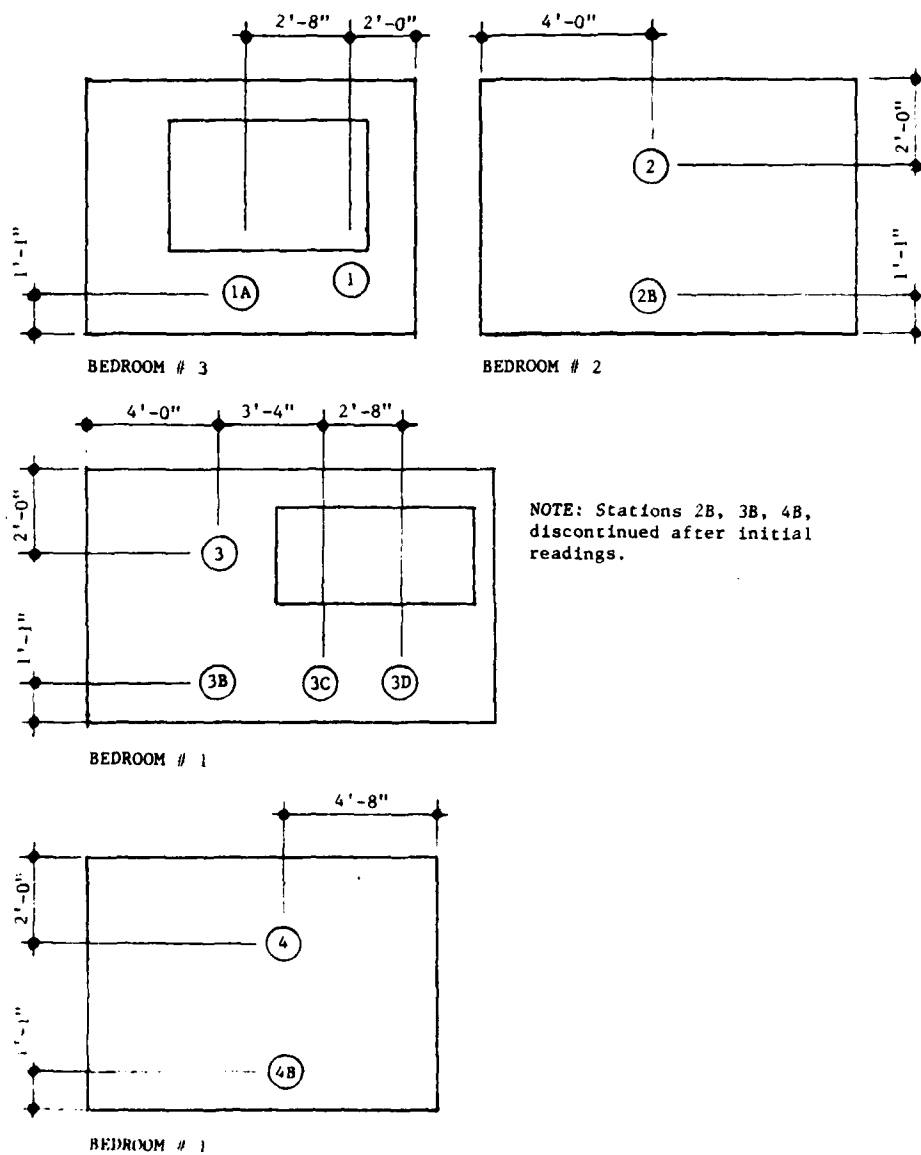
Figure 8. Stations in Corry Test House - Wall Elevations
